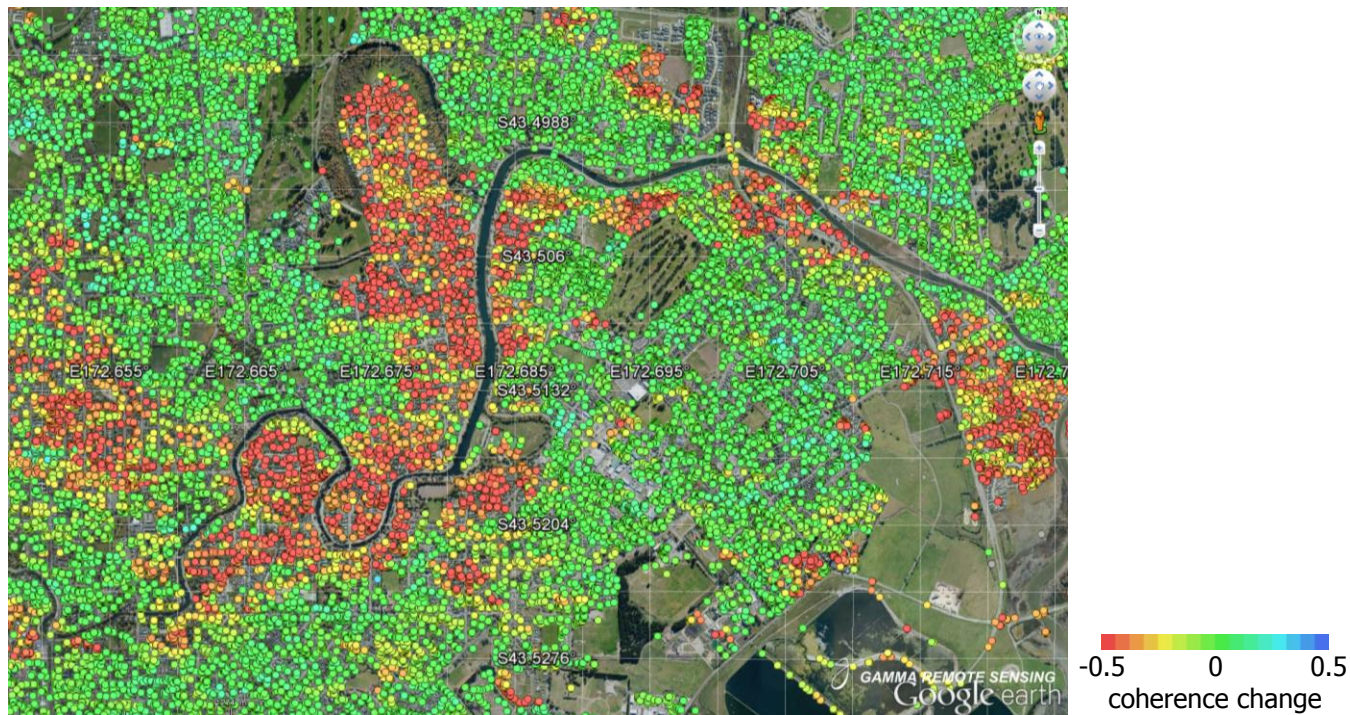
Figure 1. PSI coherence change (red indicates a strong coherence reduction) caused by the Darfield Earthquake on 3-Sep-2010 shown for a section of Christchurch, New Zealand, shown in Google Earth.

Figure 2. Map showing areas with visible liquefaction (red areas, determined in-situ) found on New Zealand government web-site (<http://data.govt.nz>). The green rectangle indicates the area shown in Figure 1.
